Alien woody plants on the retaining walls of the Vistula boulevards in Kraków, southern Poland

Pliszko A., 2022: Alien woody plants on the retaining walls of the Vistula boulevards in Kraków, southern Poland. – *Botanica*, 28(2): 102–112. <https://doi.org/10.35513/Botlit.2022.2.3>

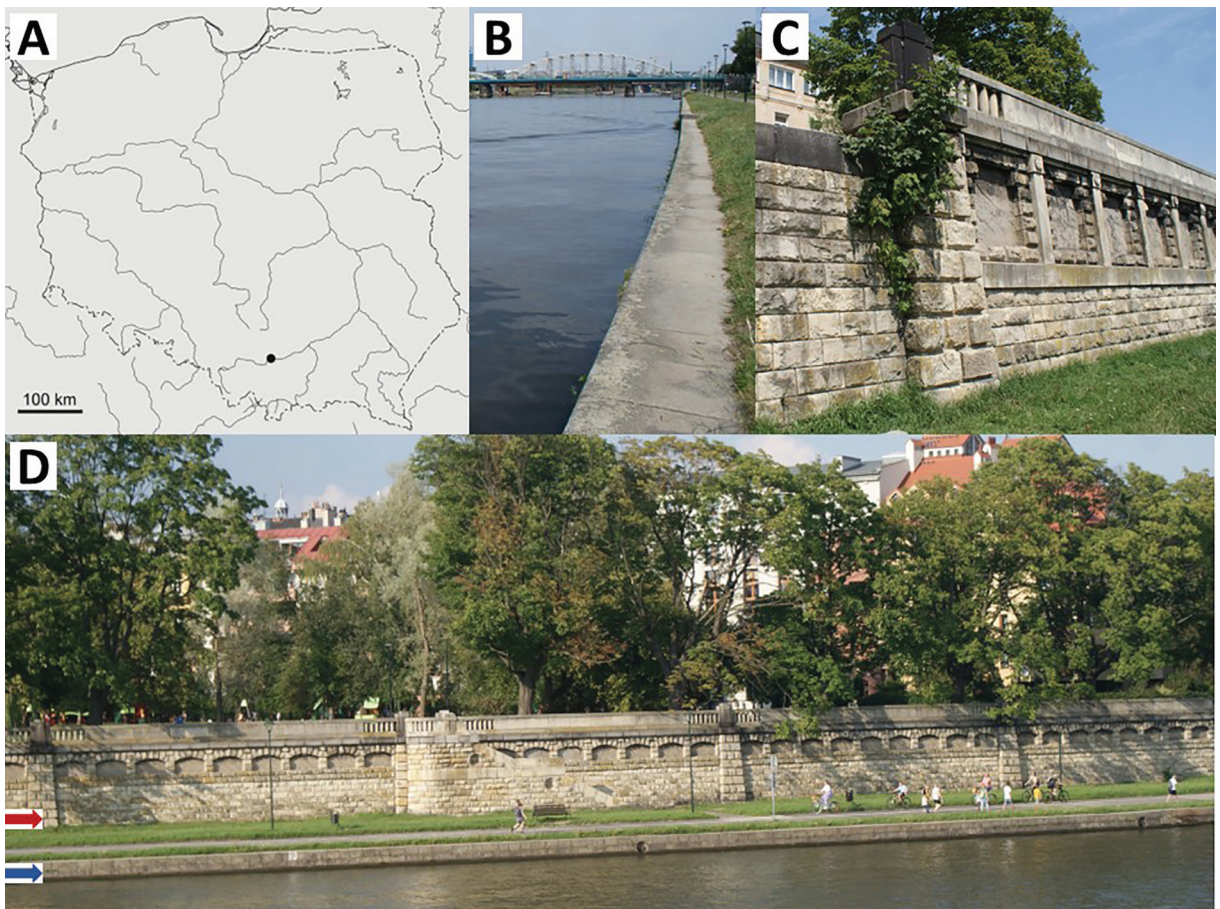
Fig. 1. Study area: A – location of Kraków in Poland, B – the lower retaining wall of Podolski Boulevard, C – the upper retaining wall of Kurlandzki Boulevard, D – lower (blue arrow) and upper (red arrow) walls of Czerwieński Boulevard (map and photos by A. Pliszko)

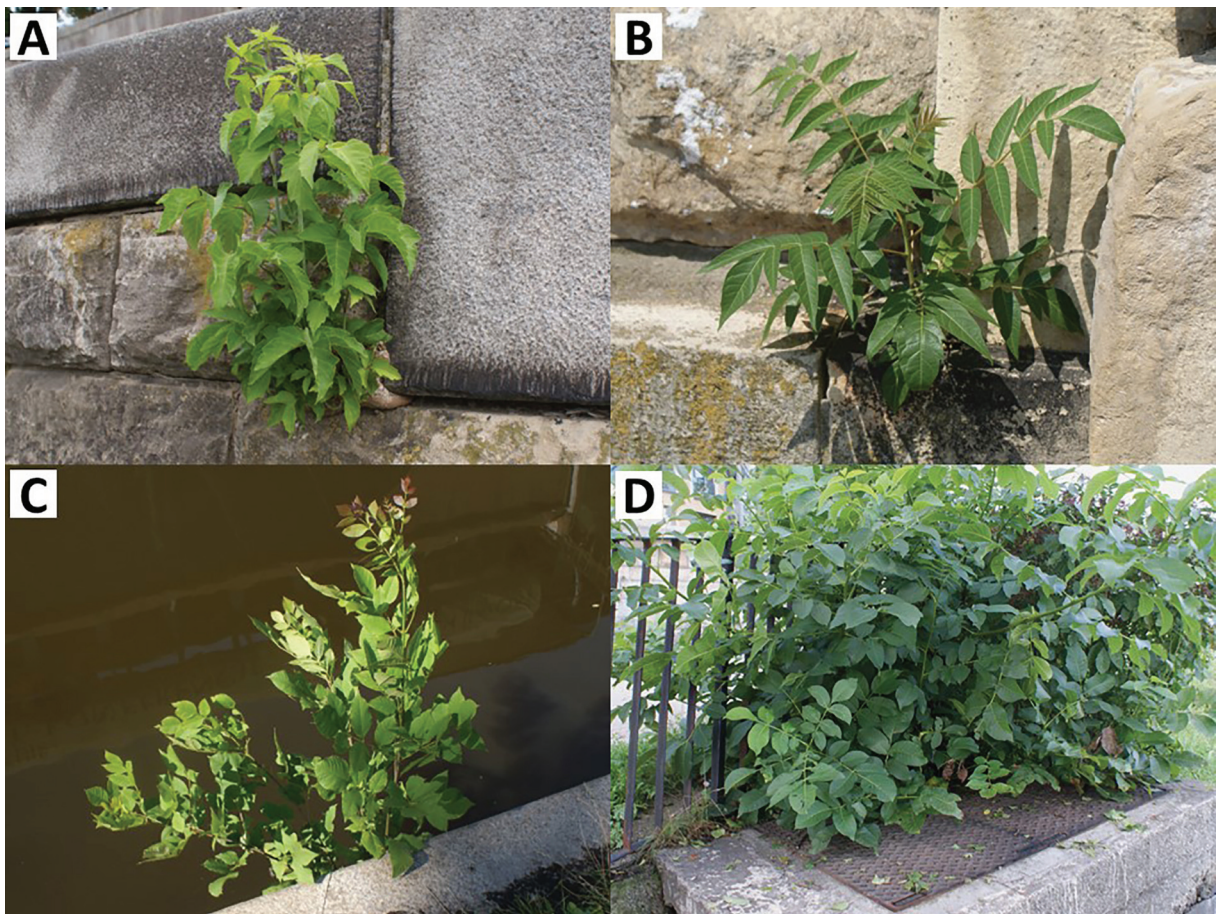
Fig. 2. Examples of alien woody plants inhabiting the retaining walls of the Vistula boulevards in Kraków, southern Poland: A – *Acer negundo* on the upper wall of Kurlandzki Boulevard, B – *Ailanthus altissima* on the upper wall of Kurlandzki Boulevard, C – *Fraxinus pennsylvanica* on the lower wall of Czerwieński Boulevard, D – *Juglans regia* on the upper wall of Poleski Boulevard (photos by A. Pliszko)

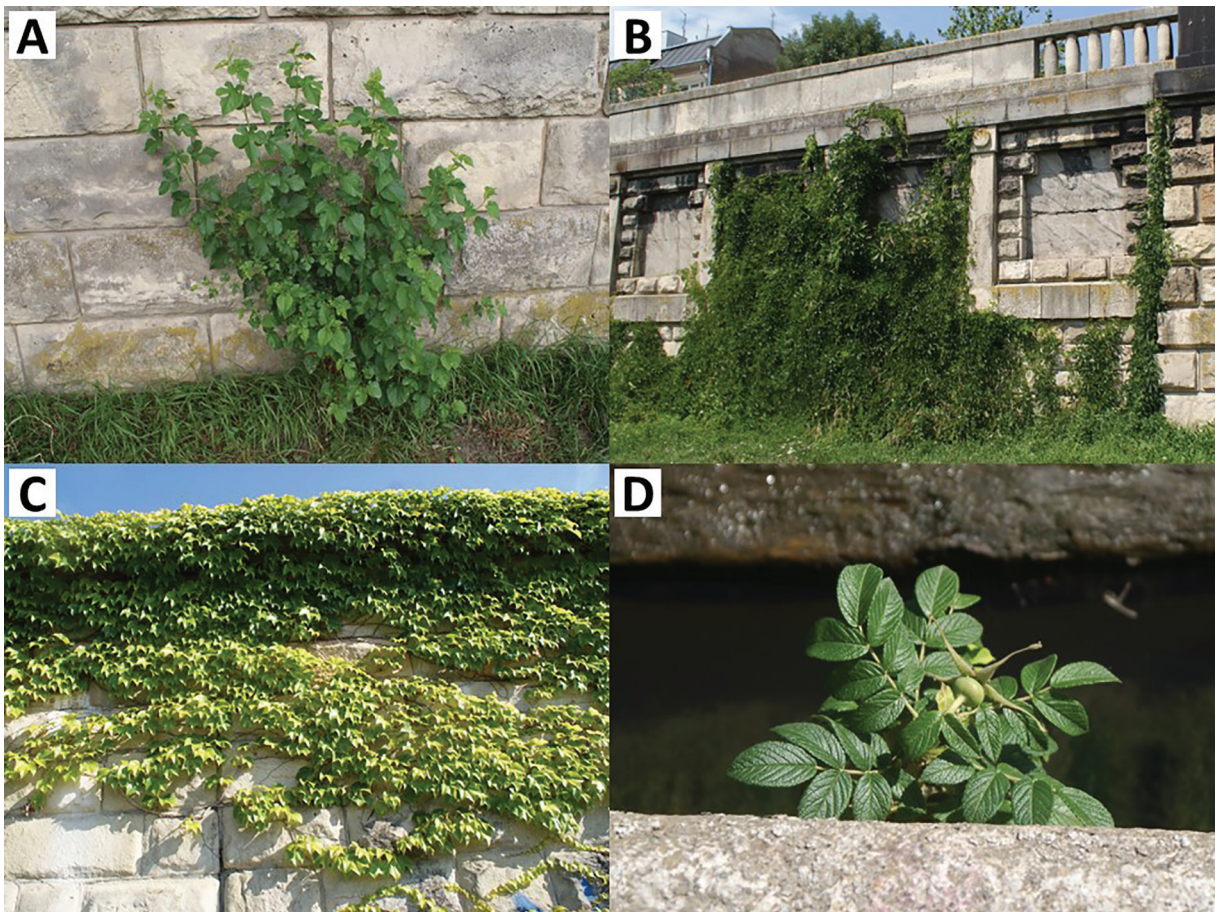
Fig. 3. Examples of alien woody plants inhabiting the retaining walls of the Vistula boulevards in Kraków, southern Poland: A – *Morus alba* at the foot of the upper wall of Kurlandzki Boulevard, B – *Parthenocissus quinquefolia* on the upper wall of Kurlandzki Boulevard, C – *Parthenocissus tricuspidata* on the upper wall of Rodła Boulevard, D – *Rosa rugosa* on the lower wall of Wołyński Boulevard (photos by A. Pliszko)
